COLUMBIA

ACCIDENT INVESTIGATION REPORT

REPORT VOLUME I
AUGUST 2003

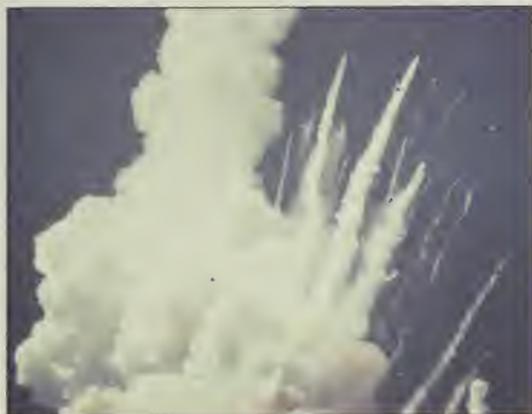
Figure 1.5-1. the Space Shuttle Challenger was lost during ascent on January 28, 1986, when an O-ring and seal in the right Solid Rocket Booster failed.

The Rogers Commission report, issued on June 6, 1986, recommended a redesign and recertification of the Solid Rocket Motor joint and seal and urged that an independent body oversee its qualification and testing. The report concluded that the drive to declare the Shuttle operational had put enormous pressures on the system and stretched its resources to the limit. Faulting NASA safety practices, the Commission also called for the creation of an independent NASA Office of Safety, Reliability, and Quality Assurance, reporting directly to the NASA Administrator, as well as structural changes in program management.²⁰ (The Rogers Commission findings and recommendations are discussed in more detail in Chapter 5.) It would take NASA 32 months before the next Space Shuttle mission was launched. During this time, NASA initiated a series of longer-term vehicle upgrades, began the construction of the Orbiter *Endeavour* to replace *Challenger*, made significant organizational changes, and revised the Shuttle manifest to reflect a more realistic flight rate.

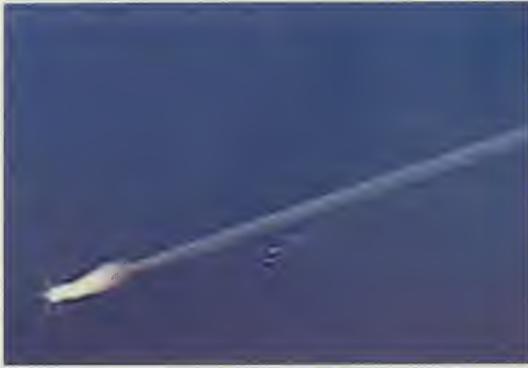
The Orbiter has a large glowing field surrounding it in this view taken from Mesquite, Texas, looking south.

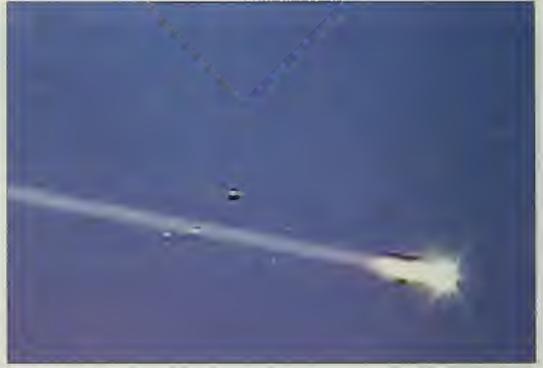
Taken at the same time as the photo at left, but from Hewitt, Texas, looking north.

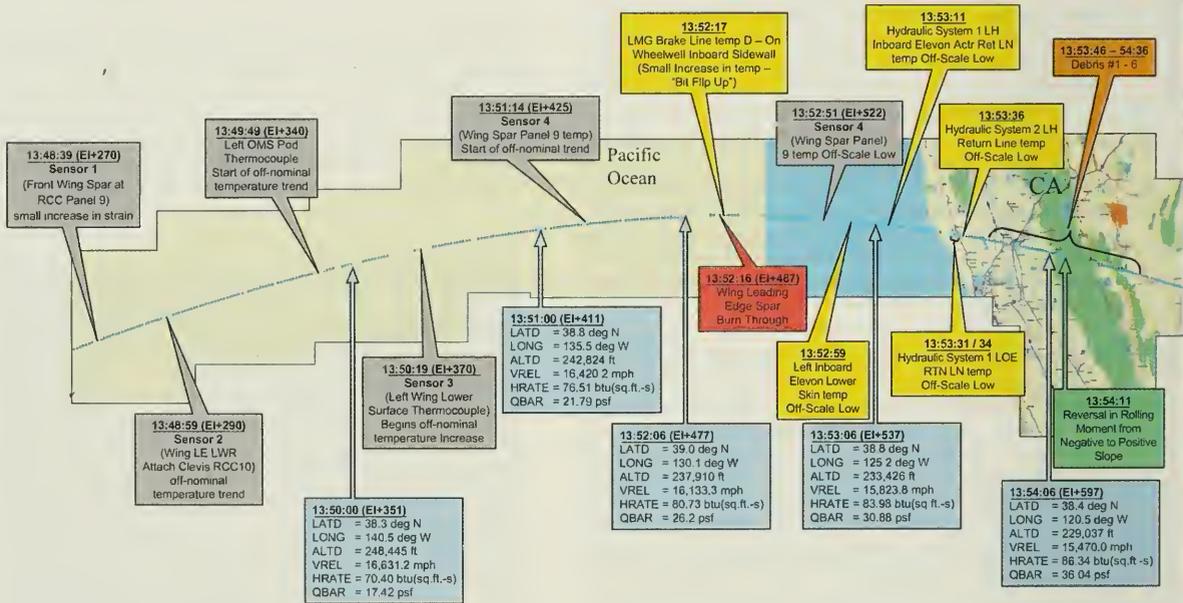
At 8:48:39 a.m. (EI+270), a sensor on the left wing leading edge spar showed strains higher than those seen on previous *Columbia* re-entries. This was recorded only on the Modular Auxiliary Data System, and was not telemetered to ground controllers or displayed to the crew (see Figure 2.6-1).

Figure 2.6-1. This simplified timeline shows the re-entry path of Columbia on February 1, 2003. The information presented here is a composite of sensor data telemetered to the ground combined with data from the Modular Auxiliary Data System recorder recovered after the accident. Note that the first off-nominal reading was a small increase in a strain gauge at the front wing spar behind RCC panel 9-left. The chart is color-coded: blue boxes contain position, attitude, and velocity information; orange boxes indicate when debris was shed from the Orbiter; green boxes are significant aerodynamic control events; gray boxes contain sensor information from the Modular Auxiliary Data System; and yellow boxes contain telemetered sensor information. The red boxes indicate other significant events.

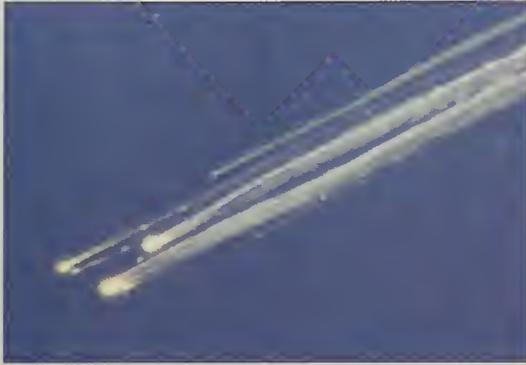
This view was taken from Dallas. (Robert McCullough/© 2003 The Dallas Morning News)

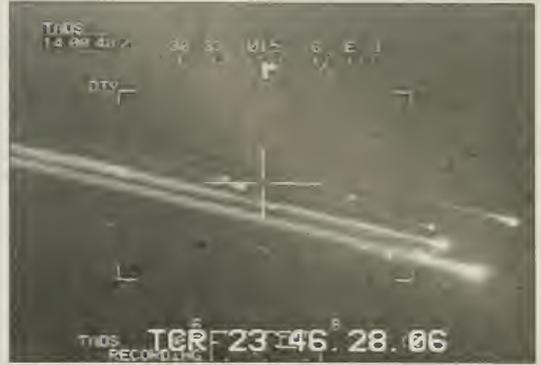
This video was captured by a Danish crew operating an AH-64 Apache helicopter near Fort Hood, Texas.

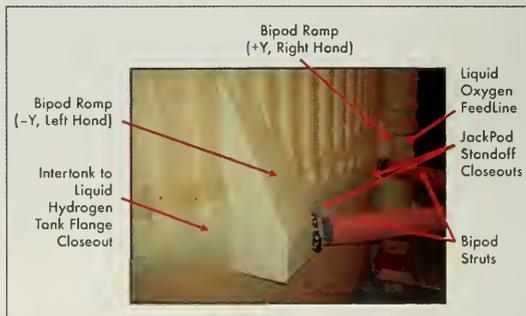
Figure 3.2-2. The exterior of the left bipod attachment area showing the foam ramp that came off during the ascent of STS-107.

A combination of factors, rather than a single factor, led to the loss of the left bipod foam ramp during the ascent of STS-107. NASA personnel believe that testing conducted during the investigation, including the dissection of as-built hardware and testing of simulated defects, showed conclusively that pre-existing defects in the foam were a major factor, and in briefings to the Board, these were cited as a necessary condition for foam loss. However, analysis indicated that pre-existing defects alone were not responsible for foam loss.

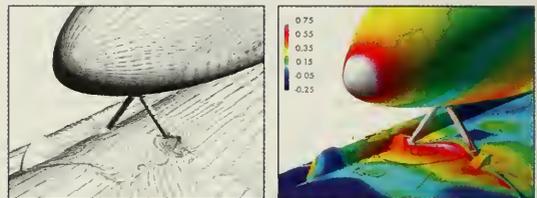
Figure 3.2-5. Computational Fluid Dynamics was used to understand the complex flow fields and pressure coefficients around bipod strut. The flight conditions shown here approximate those present when the left bipod foam ramp was lost from External Tank 93 at Mach 2.46 at a 2.08-degree angle of attack.

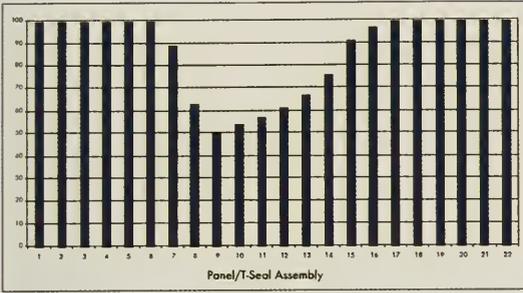
For the first five missions of *Columbia*, the RCC components were not coated with Type A sealant, and had shorter mission service lives than the RCC components on the other Orbiters. (*Columbia*'s panel 9 has the shortest mission service life of 50 flights as shown in Figure 3.3-4.) The predicted life for panel/T-seals 7 through 16 range from 54 to 97 flights.⁷

Figure 3.3-4. The expected mission life for each of the wing leading edge RCC panels on Columbia. Note that panel 9 has the shortest life expectancy.

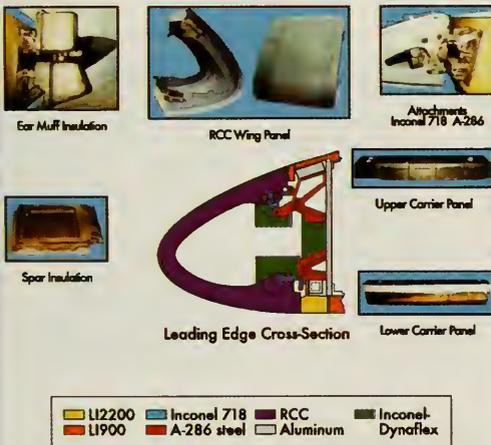
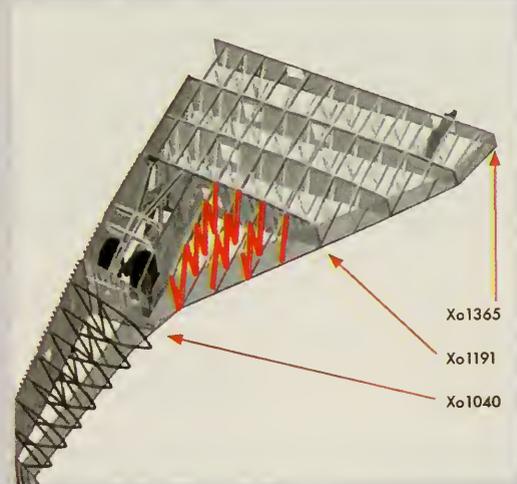
Space Shuttle Wing Leading Edge Structural System

The major internal support structures in the mid-wing are constructed from aluminum alloy. Since aluminum melts at 1,200 degrees Fahrenheit, it is likely these truss tubes in the mid-wing were destroyed and wing structural integrity was lost.

The Wing Leading Edge Structural System on Columbia.

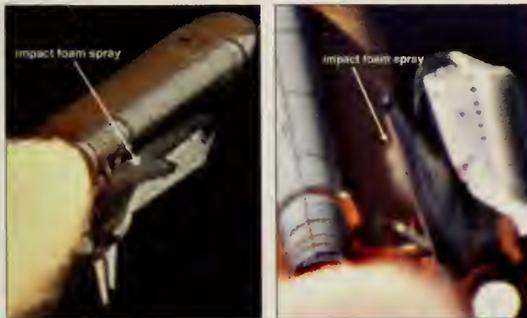
Figure 3.4-1 (color enhanced and "de-blurred" by Lockheed Martin Gaithersburg) and Figure 3.4-2 (processed by the National Imagery and Mapping Agency) are samples of the type of visual data used to establish the time of the impact (81.9 seconds), the altitude at which it occurred (65,860 feet), and the object's relative velocity at impact (about 545 mph relative to the Orbiter).

A 35-mm film camera, E212, which recorded the foam strike from 17 miles away, and video camera E208, which recorded it from 26 miles away, provided the best of the available evidence. Analysis of this visual evidence (see Figures 3.4-1 and 3.4-2) along with computer-aided design analysis, refined the potential impact area to less than 20 square feet in RCC panels 6 through 9 (see Figure 3.4-3), including a portion of the corresponding carrier panels and adjacent tiles. The investigation image analysis team found no conclusive visual evidence of post-impact debris flowing over the top of the wing.

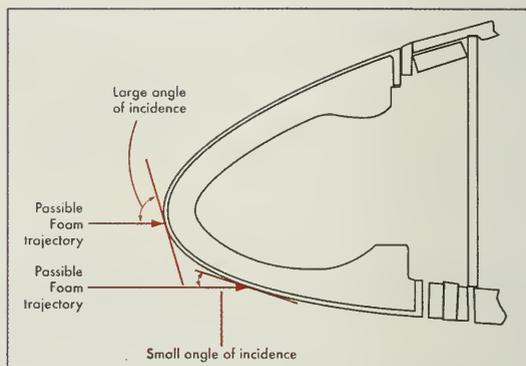
Image analysis determined that the foam was moving almost parallel to the Orbiter's fuselage at impact, with about a five-degree angle upward toward the bottom of the wing and slight motion in the outboard direction. If the foam had hit the tiles adjacent to the leading edge, the angle of incidence would have been about five degrees (the angle of incidence is the angle between the relative velocity of the projectile and the plane of the impacted surface). Because the wing leading edge curves, the angle of incidence increases as the point of impact approaches the apex of an RCC panel. Image and transport analyses estimated that for impact on RCC panel 8, the angle of incidence was between 10 and 20 degrees (see Figure 3.4-4).⁹ Because the total force delivered by the impact depends on the angle of incidence, a foam strike near the apex of an RCC panel could have delivered about twice the force as an impact close to the base of the panel.

Figure 3.4.4. This drawing shows the curve of the wing leading edge and illustrates the difference the angle of incidence has on the effect of the foam strike.

The precise impact location of the foam determined the impact angle because the debris was moving almost parallel to the Orbiter's fuselage at impact. Tile areas would have been hit at very small angles (approximately five degrees), but the curvature of the leading edge created angles closer to 20 degrees (see Figure 3.4-4).

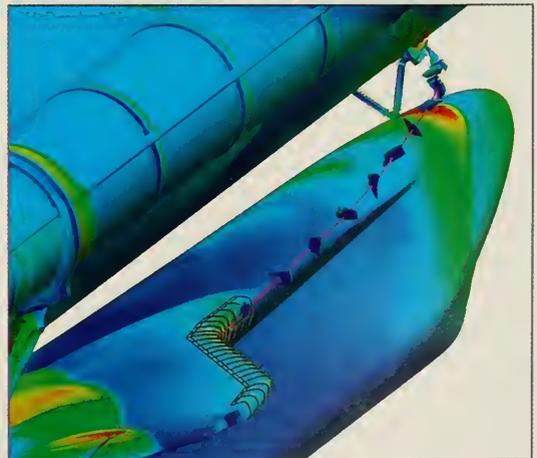
Figure 3.4-6. These are the results of a trajectory analysis that used a computational fluid dynamics approach in a program called CART-3D, a comprehensive (six-degree-of-freedom) computer simulation based on the laws of physics. This analysis used the aerodynamic and mass properties of bipod ramp foam, coupled with the complex flow field during ascent, to determine the likely position and velocity histories of the foam.

The undetermined and yet certainly irregular shape of the foam introduced substantial uncertainty about its estimated aerodynamic characteristics. Appendix D.8 contains an independent analysis conducted by the Board to confirm that the estimated range of ballistic coefficients of the foam in Figure 3.4-6 was credible, given the foam dimension results from the image analyses and the expected range of the foam density. Based on the results in Figure 3.4-7, the physical dimensions of the bipod ramp, and the sizes and shapes of the available barrels for the compressed-gas gun used in the impact test program described later in this chapter, the Board and the NASA Accident Investigation Team decided that a foam projectile 19 inches by 11.5 inches by 5.5 inches, weighing 1.67 pounds, and with a weight density of 2.4 pounds per cubic foot, would best represent the piece of foam that separated from the External Tank bipod ramp and was hit by the Orbiter’s left wing. See Section 3.8 for a full discussion of the foam impact testing.

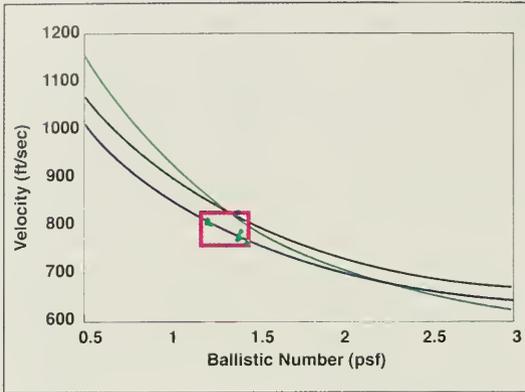
Figure 3.4-7. The results of numerous possible trajectories based on various assumed sizes, shapes, and densities of the foam. Either the foam had a slightly higher ballistic coefficient and the Orbiter struck the foam at a lower speed relative to the Orbiter, or the foam was more compact and the wing struck the foam at a higher speed. The “best fit” box represents the overlay of the data from the image analysis with the transport analysis computations. This data enabled a final selection of projectile characteristics for impact testing.

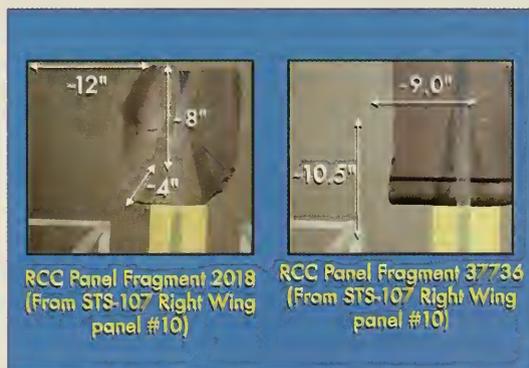
Figure 3.5-1. These representative RCC acreage pieces matched the radar cross-section of the Flight Day 2 object.

In the Advanced Compact Range at the Air Force Research Laboratory in Dayton, Ohio, analysts tested 31 materials from the Orbiter's exterior and payload bay. Additional supercomputer radar cross-section predictions were made for Reinforced Carbon-Carbon T-seals. After exhaustive radar cross-section analysis and testing, coupled with ballistic analysis of the object's orbital decay, only a fragment of RCC panel would match the UHF radar cross-section and ballistic coefficients observed by the Space Surveillance network. Such an RCC panel fragment must be approximately 140 square inches or greater in area to meet the observed radar cross-section characteristics. Figure 3.5-1 shows RCC panel fragments from *Columbia*'s right wing that represent those meeting the observed characteristics of object 2003-003B.¹⁰

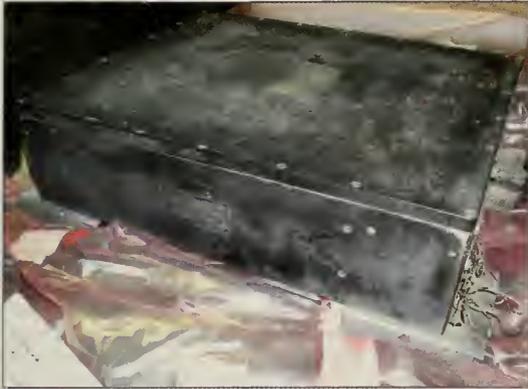
Figure 3.6-1. The Modular Auxiliary Data System recorder, found near Hemphill, Texas. While not designed to withstand impact damage, the recorder was in near-perfect condition when recovered on March 19, 2003.

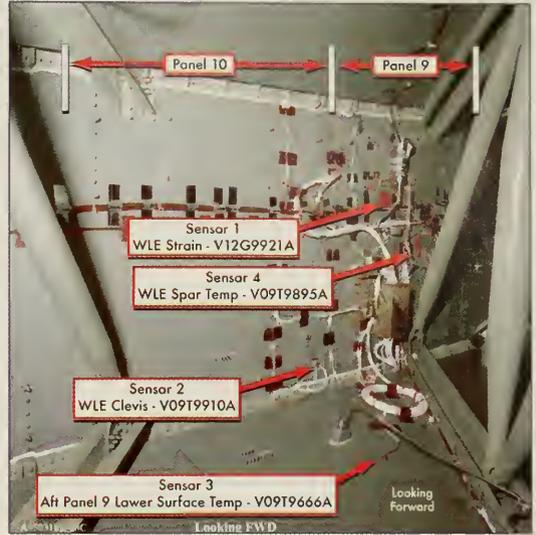
Figure 3.6-2. Location of sensors on the back of the left wing leading edge spar (vertical aluminum structure in picture). Also shown are the round truss tubes and ribs that provided the structural support for the mid-wing in this area.

or outside the wing leading edge spar near Reinforced Carbon-Carbon (RCC) panel 9-left, helped tell the story of what happened on the left wing of the Orbiter early in the re-entry. These four sensors were: strain gauge V12G9921A (Sensor 1), resistance temperature detector V09T9910A on the RCC clevis between panel 9 and 10 (Sensor 2), thermocouple V07T9666A, within a Thermal Protection System tile (Sensor 3), and resistance temperature detector V09T9895A (Sensor 4), located on the back side of the wing leading edge spar behind RCC panels 8 and 9 (see Figure 3.6-2).

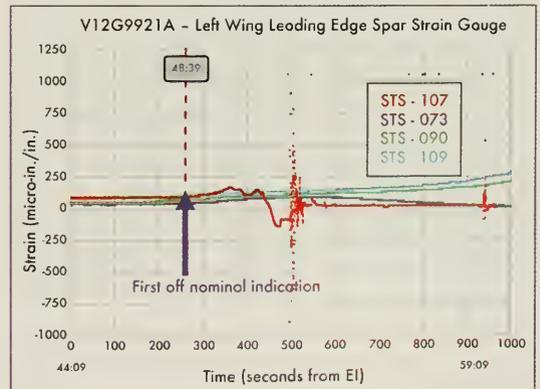
Figure 3.6-3. The strain gauge (Sensor 1) on the back of the left wing leading edge spar was the first sensor to show an anomalous reading. In this chart, and the others that follow, the red line indicates data from STS-107. Data from other Columbia re-entries, similar to the STS-107 re-entry profile, are shown in the other colors.

Sensor 1 provided the first anomalous reading (see Figure 3.6-3). From EI+270 to EI+360, the strain is higher than that on previous *Columbia* flights. At EI+450, the strain reverses, and then peaks again in a negative direction at EI+475. The strain then drops slightly, and remains constant and negative until EI+495, when the sensor pattern becomes unreliable, probably due to a propagating soft short, or “burn-through” of the insulation between cable conductors caused by heating or combustion. This strain likely indicates significant damage to the aluminum honeycomb spar. In particular, strain reversals, which are unusual, likely mean there was significant high-temperature damage to the spar during this time.

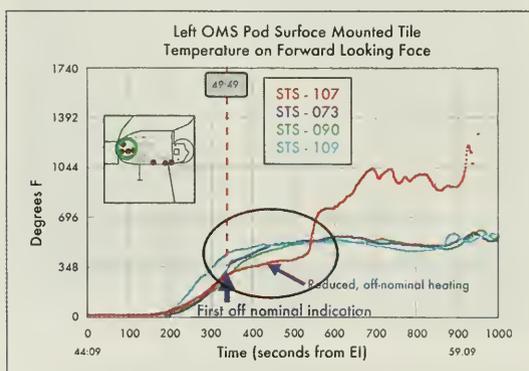
Figure 3.6-9. Orbital Maneuvering System (OMS) pod heating was initially significantly lower than that seen on previous Columbia missions. As wing leading edge damage later increased, the OMS pod heating increased dramatically. Debris recovered from this area of the OMS pod showed substantial pre-breakup heat damage and imbedded drops of once-molten metal from the wing leading edge in the OMS pod thermal tiles.

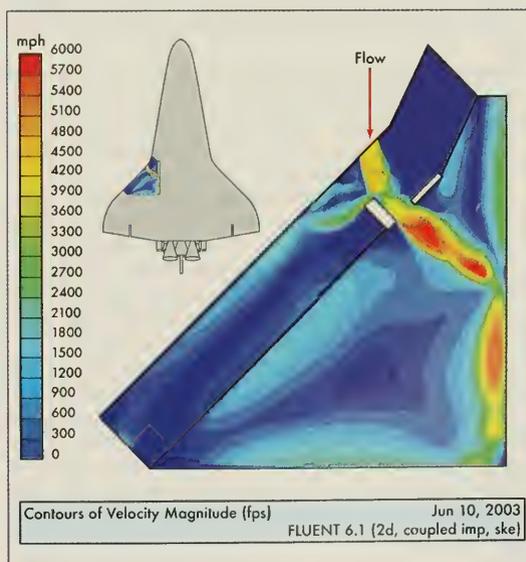
Later computational fluid dynamics analysis of the mid-wing area behind the spar showed that superheated air flowing into a breached RCC panel 8 and then interacting with the internal structure behind the RCC cavity (RCC ribs and spar insulation) would have continued through the wing leading edge spar as a jet, and would have easily allowed superheated air to traverse the 56.5 inches from the spar to the outside of the wheel well and destroy the cables (Figure 3.6-11). Controllers on the ground saw these first anomalies in the telemetry data at EI+613, when four hydraulic sensor cables that ran from the aft part of the left wing through the wiring bundles outside the wheel well failed.

Figure 3.6-11. The computational fluid dynamics analysis of the speed of the superheated air as it entered the breach in RCC panel 8 and then traveled through the wing leading edge spar. The darkest red color indicates speeds of over 4,000 miles per hour. Temperatures in this area likely exceeded 5,000 degrees Fahrenheit. The area of detail is looking down at the top of the left wing.

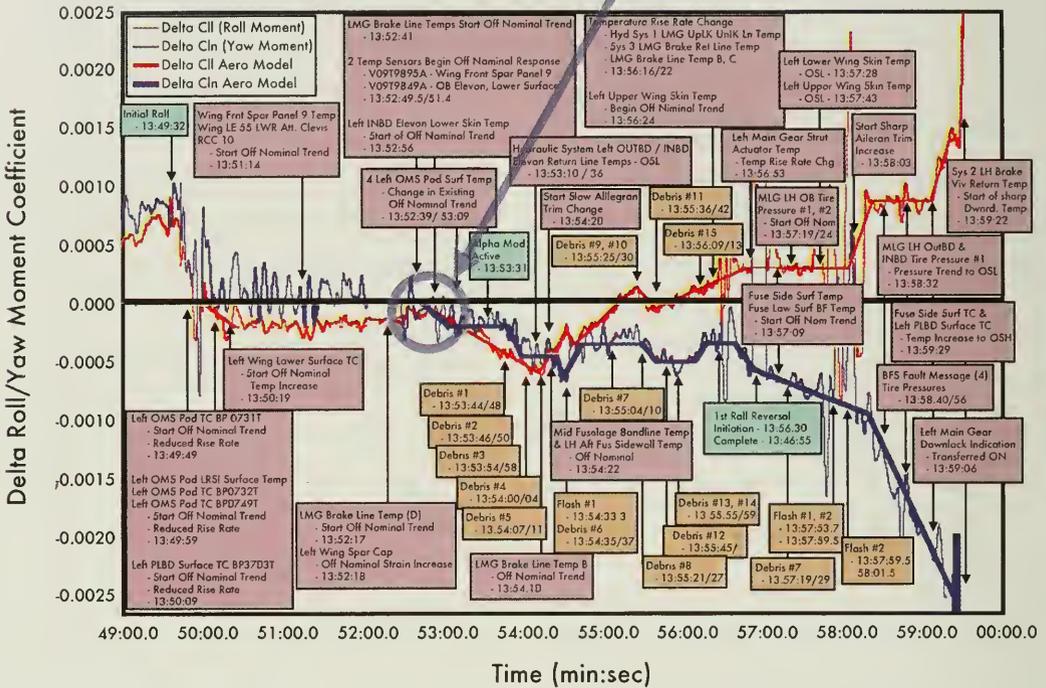
STS 107 Delta Rolling/Yawing Moment Coefficients
Off-Nominal Roll & Yaw

Aerodynamic roll and yaw forces began to differ from those on previous flights at about EI+500 (see Figure 3.6-12). Investigators used flight data to reconstruct the aerodynamic forces acting on the Orbiter. This reconstructed data was then compared to forces seen on other similar flights of *Columbia*

Figure 3.6-12. At approximately EI+500 seconds, the aerodynamic roll and yaw forces began to diverge from those observed on previous flights. The blue line shows the Orbiter's tendency to yaw while the red line shows its tendency to roll. Nominal values would parallel the solid black line. Above the black line, the direction of the force is to the right, while below the black line, the force is to the left.

and to the forces predicted for STS-107. In the early phase of flight, these abnormal aerodynamic forces indicated that *Columbia's* flight control system was reacting to a change in the external shape of the wing, which was caused by progressive RCC damage that caused a continuing decrease in lift and a continuing increase in drag on the left wing.

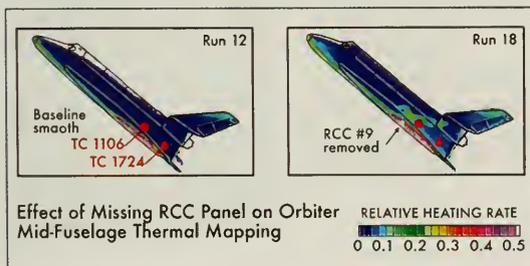
Figure 3.6-13. The effects of removing RCC panel 9 are shown in this figure. Note the brighter colors on the front of the OMS pod show increased heating, a phenomenon supported by both the OMS pod temperature sensors and the debris analysis.

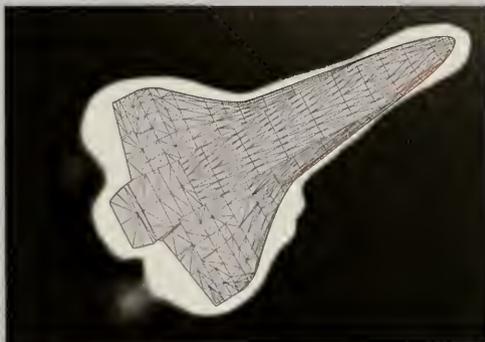
THE KIRTLAND IMAGE

As *Columbia* passed over Albuquerque, New Mexico, during re-entry (around EI+795), scientists at the Air Force Starfire Optical Range at Kirtland Air Force Base acquired images of the Orbiter. This imaging had not been officially assigned, and the photograph was taken using commercial equipment located at the site, not with the advanced Starfire adaptive-optics telescope.

The image shows an unusual condition on the left wing, a leading-edge disturbance that might indicate damage. Several analysts concluded that the distortion evident in the image likely came from the modification and interaction of shock waves due to the damaged leading edge. The overall appearance of the leading-edge damage at this point on the trajectory is consistent with the scenario.

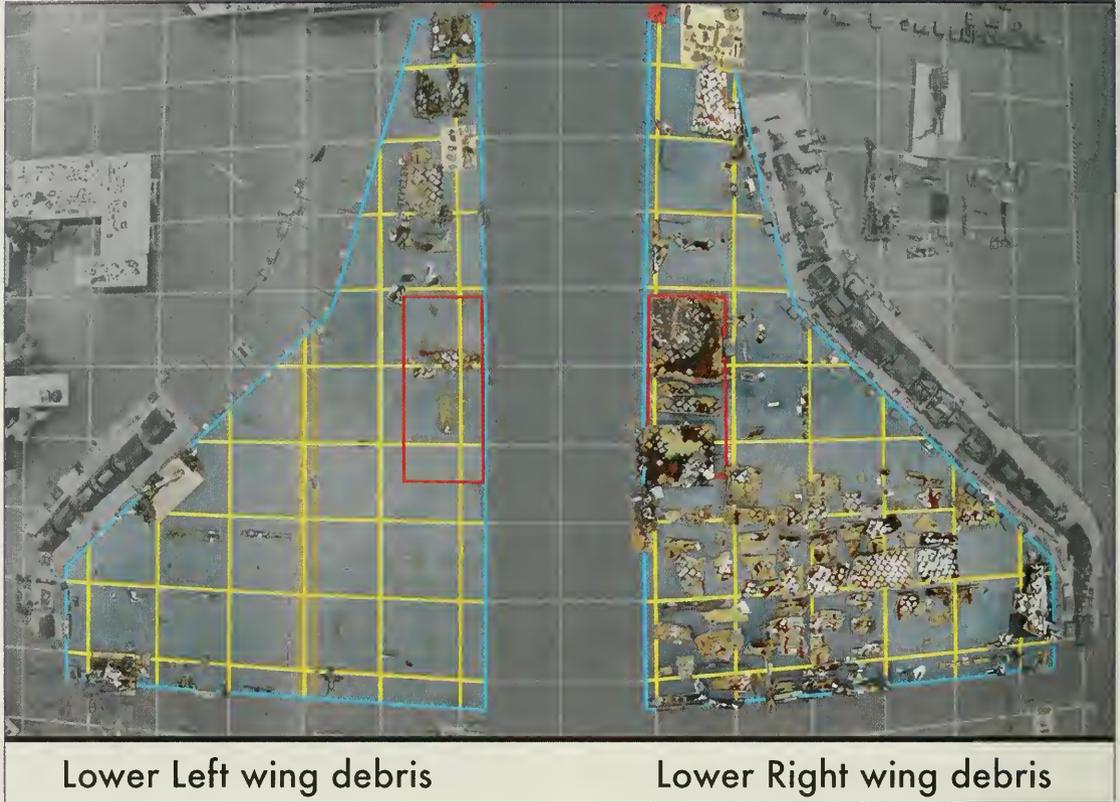
Figure 3.7-1. Comparison of amount of debris recovered from the left and right wings of Columbia. Note the amount of debris recovered from areas in front of the wheel well (the red boxes on each wing) were similar, but there were dramatic differences in the amount of debris recovered aft of each wheel well.

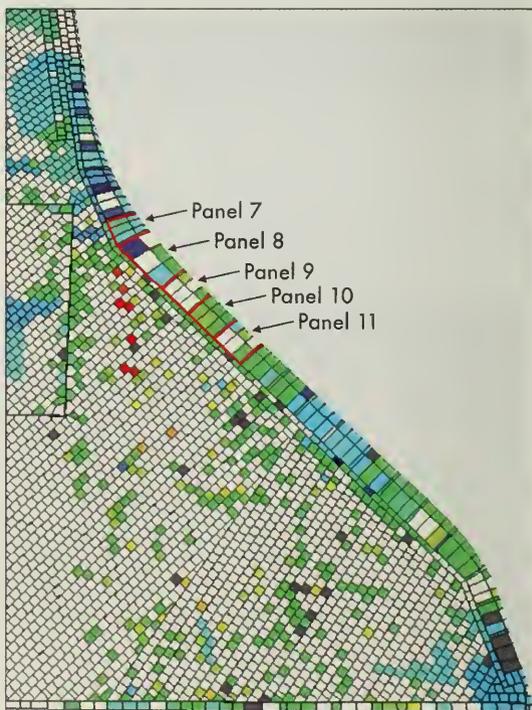
Figure 3.7-6. The tiles recovered farthest west all came from the area immediately behind left wing RCC panels 8 and 9. In the figure, each small box represents an individual tile on the lower surface of the left wing. The more red an individual tile appears, the farther west it was found.

An analysis of where tiles were found on the ground also yielded significant evidence of the breach location. Since most of the tiles are of similar size, weight, and shape, they would all have similar ballistic coefficients and would have behaved similarly after they separated from the Orbiter. By noting where each tile fell and then plotting its location on the Orbiter tile map, a distinctive pattern emerged. The tiles recovered farthest west all came from the area immediately behind the left wing RCC panel 8 and 9 (see Figure 3.7-6), which suggests that these tiles were released earlier than those from other areas of the left wing. While it is not conclusive evidence of a breach in this area, this pattern does suggest unique damage around RCC panels 8 and 9 that was not seen in other areas. Tiles from this area also showed evidence of a brown deposit that was not seen on tiles from any

other part of the Orbiter. Chemical analysis revealed it was an Inconel-based deposit that had come from inside the RCC cavity on the left wing (Inconel is found in wing leading edge attachment fittings). Since the streamlines from tiles with the brown deposit originate near left RCC panels 8 and 9, this brown deposit likely originated as an outflow of superheated air and molten metal from the panel 8 and 9 area.

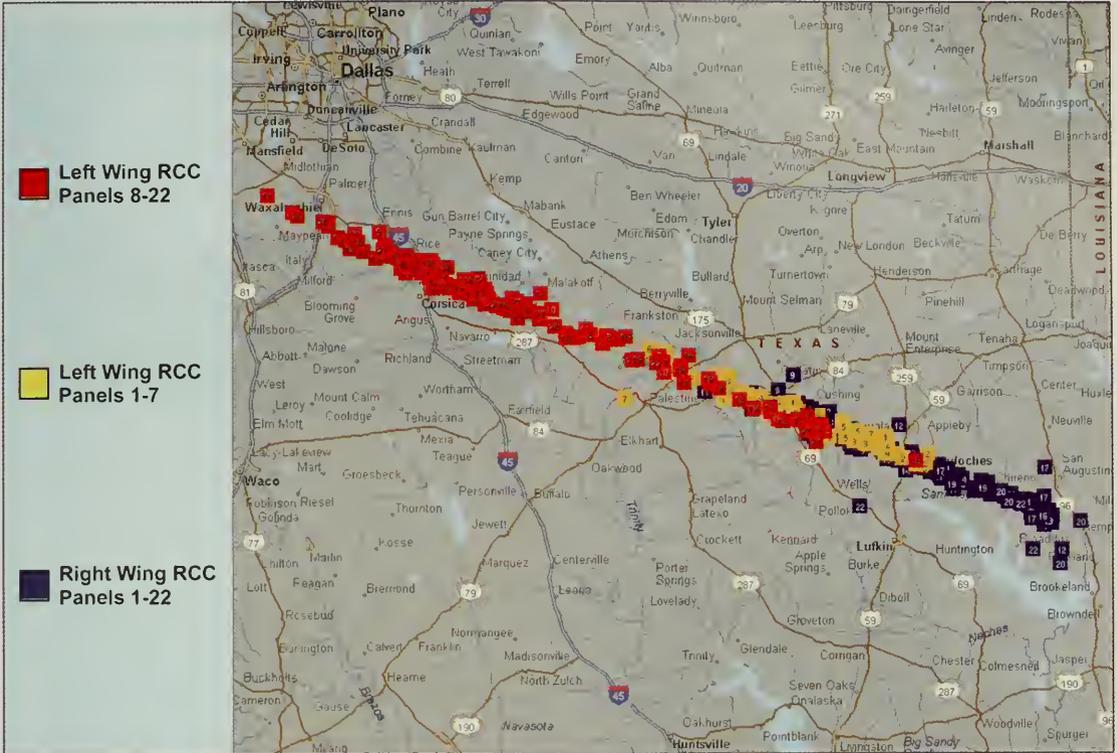
The location of debris on the ground also provided evidence of where the initial breach occurred. The location of every piece of recovered RCC was plotted on a map and labeled according to the panel the piece originally came from. Two distinct patterns were immediately evident. First, it was clear that pieces from left wing RCC panels 9 through 22 had fallen the farthest west, and that RCC from left wing panels 1 through 7 had fallen considerably farther east (see Figure 3.7-5). Second, pieces from left wing panel 8 were

Figure 3.7-5. The location of RCC panel debris from the left and right wings, shown where it was recovered from in East Texas. The debris pattern suggested that the left wing failed before the right wing, most likely near left RCC panels 8 and 9.

found throughout the debris field, which suggested that the left wing likely failed in the vicinity of RCC panel 8. The early loss of the left wing from RCC panel 9 and outboard caused the RCC from that area to be deposited well west of the RCC from the inboard part of the wing. Since panels 1 through 7 were so much farther to the east, investigators concluded that RCC panels 1 through 7 had stayed with the Orbiter longer than had panels 8 through 22.

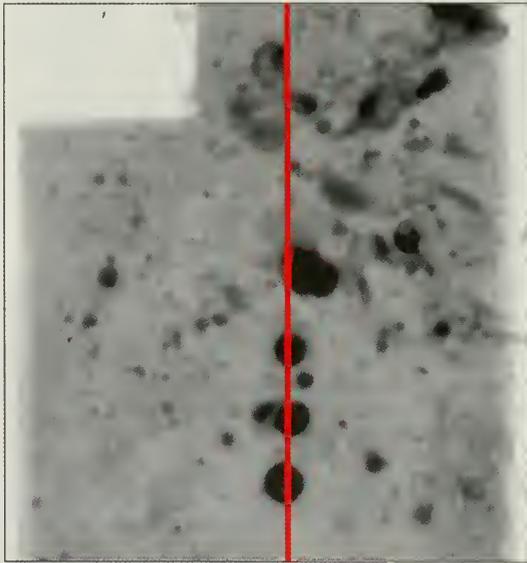
The X-ray analysis of left wing RCC panel 8 (see Figure 3.7-7) showed a bottom-to-top pattern of slag deposits. In some areas, small spheroids of heavy metal were aligned vertically on the recovered pieces, which indicated a superheated airflow from the bottom of the panel toward the top in the area of RCC panel 8-left. These deposits were later determined by chemical analysis to be Inconel 718, probably from the wing leading edge attachment fittings on the spanner beams on RCC panels 8 and 9. Computational fluid dynamics modeling of the flow behind panel 8 indicated that the molten deposits would be laid down in this manner.

Figure 3.7-7. X-ray analysis of RCC panel 8-left showed a bottom-to-top pattern of slag deposits.

The layered deposits on panel 8 were also markedly different from those on all other left- and right-wing panels. There was much more material deposited on RCC panel 8-left. These deposits had a much rougher overall structure, including rivulets of Cerachrome slag deposited directly on the RCC. This indicated that Cerachrome, the insulation that protects the wing leading edge spar, was one of the first materials to succumb to the superheated air entering through the breach in RCC panel 8-left. Because the melting temperature of Cerachrome is greater than 3,200 degrees Fahrenheit, analysis indicated that materials in this area were exposed to extremely

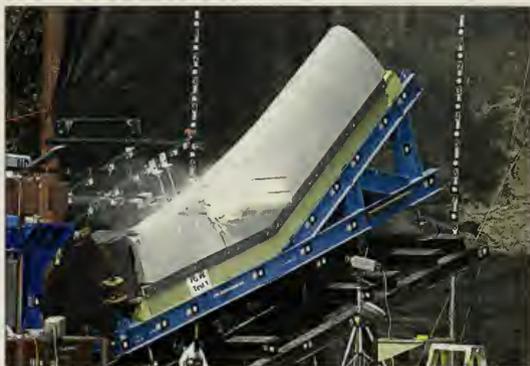
Five engineering tests on fiberglass panels (see Figure 3.8-5) established the test parameters of the impact tests on RCC panels. Details of the fiberglass tests are in Appendix D.12.

Figure 3.8-5. A typical foam strike leaves impact streaks, and the foam projectile breaks into shards and larger pieces. Here the foam is striking Panel 6 on a fiberglass test article.

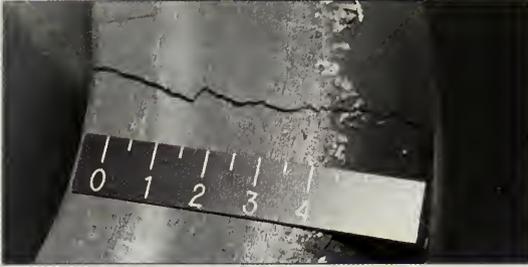
RCC panel 6 was tested first to begin to establish RCC impact response, although by the time of the test, other data had indicated that RCC panel 8-left was the most likely site of the breach. RCC panel 6 was impacted using the same parameters as the test on fiberglass panel 6 and developed a 5.5-inch crack on the outboard end of the panel that extended through the rib (see Figure 3.8-6). There was also a crack through the "web" of the T-seal between panels 6 and 7 (see Figure 3.8-7). As in the fiberglass test, the foam block deflected, or moved, the face of the RCC panel, creating a slit between the panel and the adjacent T-seal, which ripped the projectile and stuffed pieces of foam into the slit (see Figure 3.8-8). The panel rib failed at lower stresses than predicted, and the T-seal failed closer to predictions, but overall, the stress pattern was similar to what was predicted, demonstrating the need to incorporate more complete RCC failure criteria in the computational models.

Without further crack growth, the specific structural damage this test produced would probably not have allowed enough superheated air to penetrate the wing during re-entry to cause serious damage. However, the test did demonstrate that a foam impact representative of the debris strike at 81.9 seconds after launch could damage an RCC panel. Note that

Figure 3.8-6. A 5.5-inch crack on the outboard portion of RCC Panel 6 during testing.

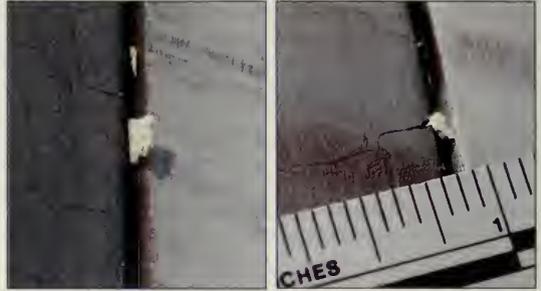
Figure 3.8-8. Two views of foam lodged into the slit during tests.

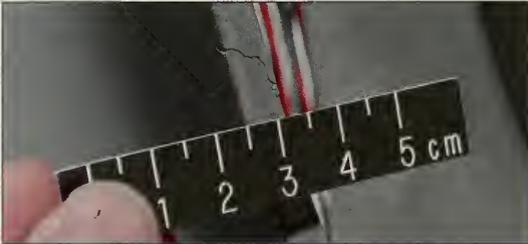
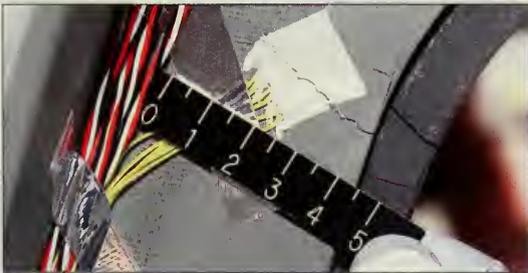
Figure 3.8-7. Two views of the crack in the T-seal between RCC Panels 6 and 7.

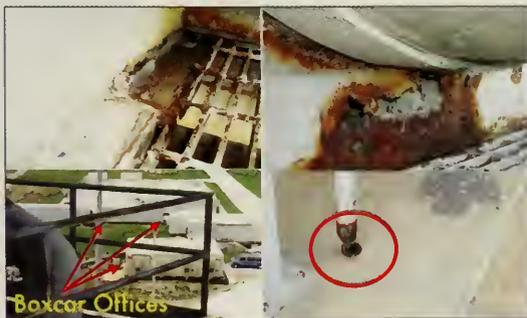
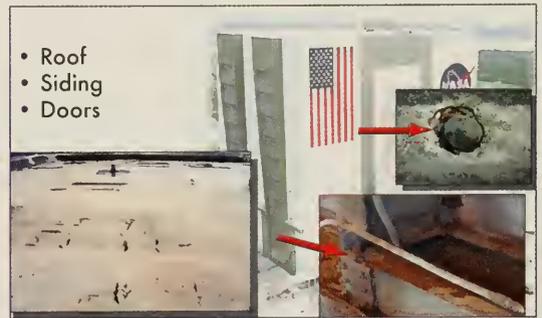
Figure 5.5-5 and 5.5-6. Examples of the seriously deteriorating infrastructure used to support the Space Shuttle Program. At left is Launch Complex 39A, and at right is the Vehicle Assembly building, both at the Kennedy Space Center.

Board investigators have identified deteriorating infrastructure associated with the launch pads, Vehicle Assembly Building, and the crawler transporter. Figures 5.5-5 and 5.5-6 depict some of this deterioration. For example, NASA has installed nets, and even an entire sub-roof, inside the Vehicle Assembly Building to prevent concrete from the building’s ceiling from hitting the Orbiter and Shuttle stack. In addition, the corrosion-control challenge results in zinc primer

on certain launch pad areas being exposed to the elements. When rain falls on these areas, it carries away zinc, runs onto the leading edge of the Orbiter’s wings, and causes pinholes in the Reinforced Carbon-Carbon panels (see Chapter 3).

In 2000, NASA identified 100 infrastructure items that demanded immediate attention. NASA briefed the Space Flight Advisory Committee on this “Infrastructure Revitalization” initiative in November of that year. The Committee concluded that “deteriorating infrastructure is a serious, major problem,” and, upon touring several Kennedy Space Center facilities, declared them “in deplorable condition.”⁶⁷ NASA subsequently submitted a request to the White House Office of Management and Budget during Fiscal Year 2002 budget deliberations for \$600 million to fund the infrastructure initiative. No funding was approved.

In Fiscal Year 2002, Congress added \$25 million to NASA’s budget for Vehicle Assembly Building repairs. NASA has reallocated limited funds from the Shuttle budget to pressing infrastructure repairs, and intends to take an integrated look at infrastructure as part of its new Shuttle Service Life Extension Program. Nonetheless, like Space Shuttle upgrades, infrastructure revitalization has been mired by the uncertainty surrounding the Shuttle Program’s lifetime. Considering that the Shuttle will likely be flying for many years to come, NASA, the White House, and Congress alike now face the specter of having to deal with years of infrastructure neglect.

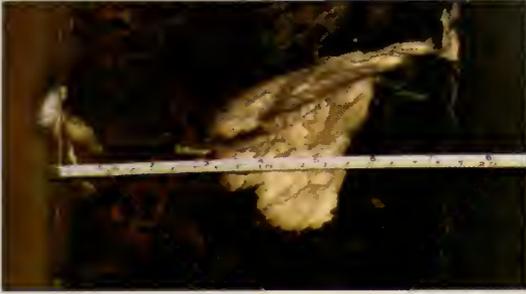
The sixth and final bipod ramp event before STS-107 occurred during STS-112 on October 7, 2002 (see Figure 6.1-3). At 33 seconds after launch, when *Atlantis* was at 12,500 feet and traveling at Mach 0.75, ground cameras observed an object traveling from the External Tank that subsequently impacted the Solid Rocket Booster/External Tank Attachment ring (see Figure 6.1-4). After impact, the debris broke into multiple pieces that fell along the Solid Rocket Booster exhaust plume.¹⁵ Post-mission inspection of the Solid Rocket Booster confirmed damage to foam on the forward face of the External Tank Attachment ring. The impact was approximately 4 inches wide and 3 inches deep. Post-External Tank separation photography by the crew showed that a 4- by 5- by 12-inch (240 cubic-inch) corner section of the left bipod ramp was missing, which exposed the super lightweight ablator coating on the bipod housing. This missing chunk of foam was believed to be the debris that impacted the External Tank Attachment ring during ascent. The post-launch review of photos and video identified these debris events, but the Mission Evaluation Room logs and Mission Management Team minutes do not reflect any discussions of them.

Figure 6.1-4. On STS-112, the foam impacted the External Tank Attach ring on the Solid Rocket Booster, causing this tear in the insulation on the ring.

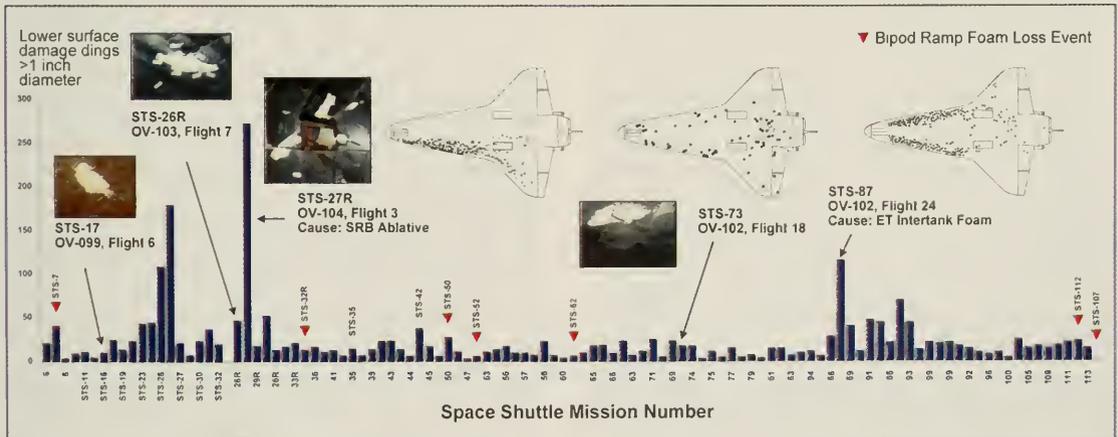
Figure 6.1-6. This chart shows the number of dings greater than one inch in diameter on the lower surface of the Orbiter after each mission from STS-6 through STS-113. Flights where the bipod ramp foam is known to have come off are marked with a red triangle.

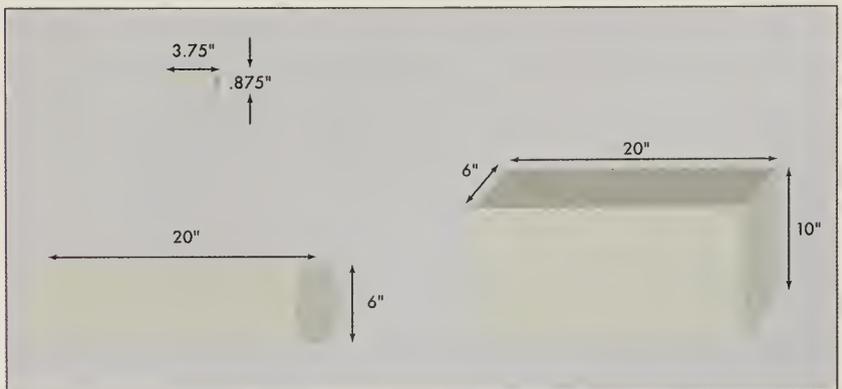
Until STS-107, Crater was normally used only to predict whether small debris, usually ice on the External Tank, would pose a threat to the Orbiter during launch. The use of Crater to assess the damage caused by foam during the launch of STS-107 was the first use of the model while a mission was on orbit. Also of note is that engineers used Crater during STS-107 to analyze a piece of debris that was at maximum 640 times larger in volume than the pieces of debris used to calibrate and validate the Crater model (the Board's best estimate is that it actually was 400 times larger). Therefore, the use of Crater in this new and very different situation compromised NASA's ability to accurately predict debris damage in ways that Debris Assessment Team engineers did not fully comprehend (see Figure 6.3-1).

Figure 6.3-1. The small cylinder at top illustrates the size of debris Crater was intended to analyze. The larger cylinder was used for the STS-107 analysis; the block at right is the estimated size of the foam.

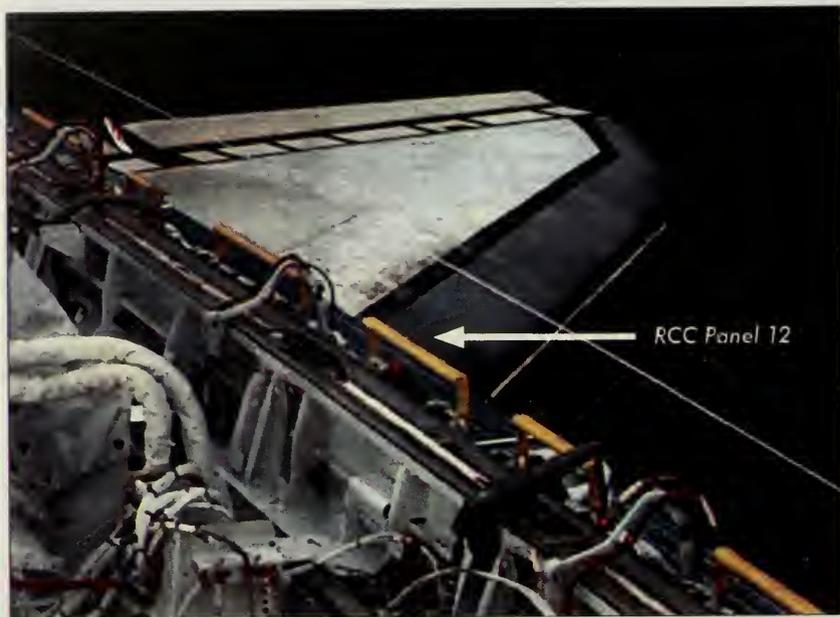
This photo from the aft flight deck window of an Orbiter shows that RCC panels 1 – 11 are not visible from inside the Orbiter. Since Columbia did not have a manipulator arm for STS-107, it would have been necessary for an astronaut to take a spacewalk to visibly inspect the inboard leading edge of the wing.

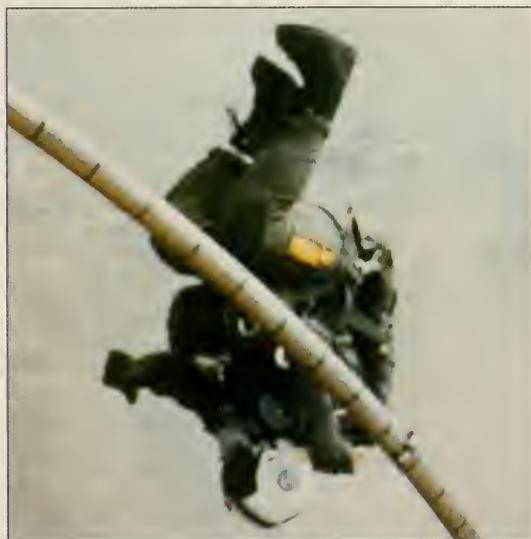
In response to this recommendation, NASA developed the current “pole bailout” system for use during controlled, subsonic gliding flight (see Figure 10.2-1). The system requires crew members to “vent” the cabin at 40,000 feet (to equalize the cabin pressure with the pressure at that altitude), jettison the hatch at approximately 32,000 feet, and then jump out of the vehicle (the pole allows crew members to avoid striking the Orbiter’s wings).

Figure 10.2-1. A demonstration of the pole bailout system. The pole is extending from the side of a C-141 simulating the Orbiter, with a crew member sliding down the pole so that he would fall clear of the Orbiter’s wing during an actual bailout.

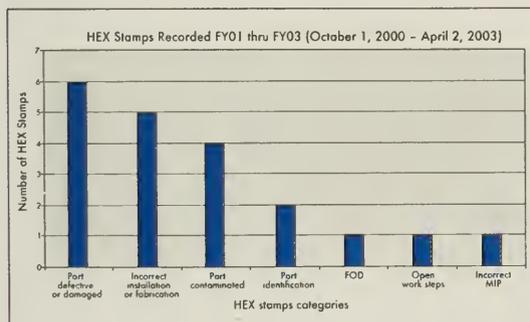
Of the 141,127 inspections subject to rejection from October 2000 through March 2003, only 20 rejections, or "hexes," were recorded, resulting in a statistically improbable discrepancy rate of .014 percent (see Figure 10.4-4). In interviews, technicians and inspectors alike confirmed the dubiousness of this rate. NASA's published rejection rate therefore indicates either inadequate documentation or an underused system. Testimony further revealed incidents of quality assurance inspectors being played against each other to accept work that had originally been refused.

Figure 10.4-4. Rejection, or "Hex" stamps issued from October 2000 through April 2003.
